# **MISSION SAFETY EVALUATION REPORT FOR STS-37**

## **Postflight Edition**

### **Safety Division**

### **Office of Safety and Mission Quality**

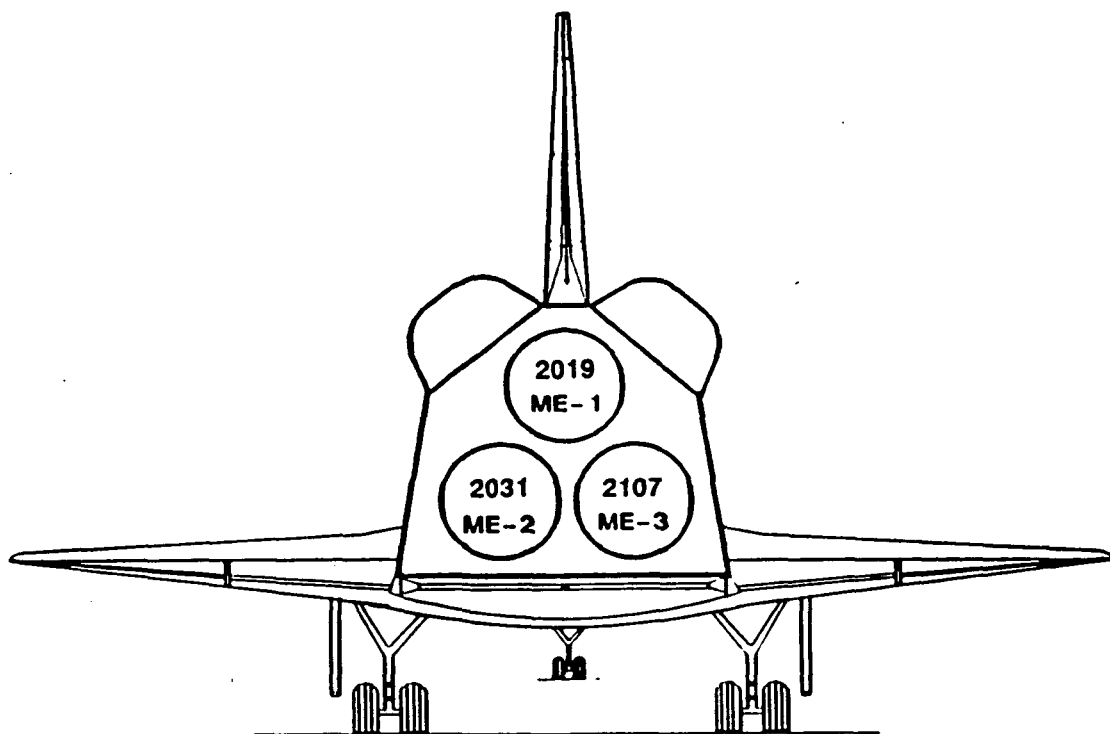
ENGINE	#2019	#2031	#2107
POWERHEAD	#2020	#2028	#2014
MCC*	#2023	#2019	#4002
NOZZLE	#2024	#4017	#4019
CONTROLLER	F4	F29	F25
FASCOS*	#23	#12	#29
HPFTP*	#6008	#4010R3	#6003R1
LPFTP*	#2022R1	#2120R1	#4007
HPOTP*	#9309R2	#2027R3	#2521R2
LPOTP*	#2025R1	#2120	#2216
